ANNUAL SITE INSPECTION REPORT

JULY 2000

BAILEY SUPERFUND SITE

SEPTEMBER 2000

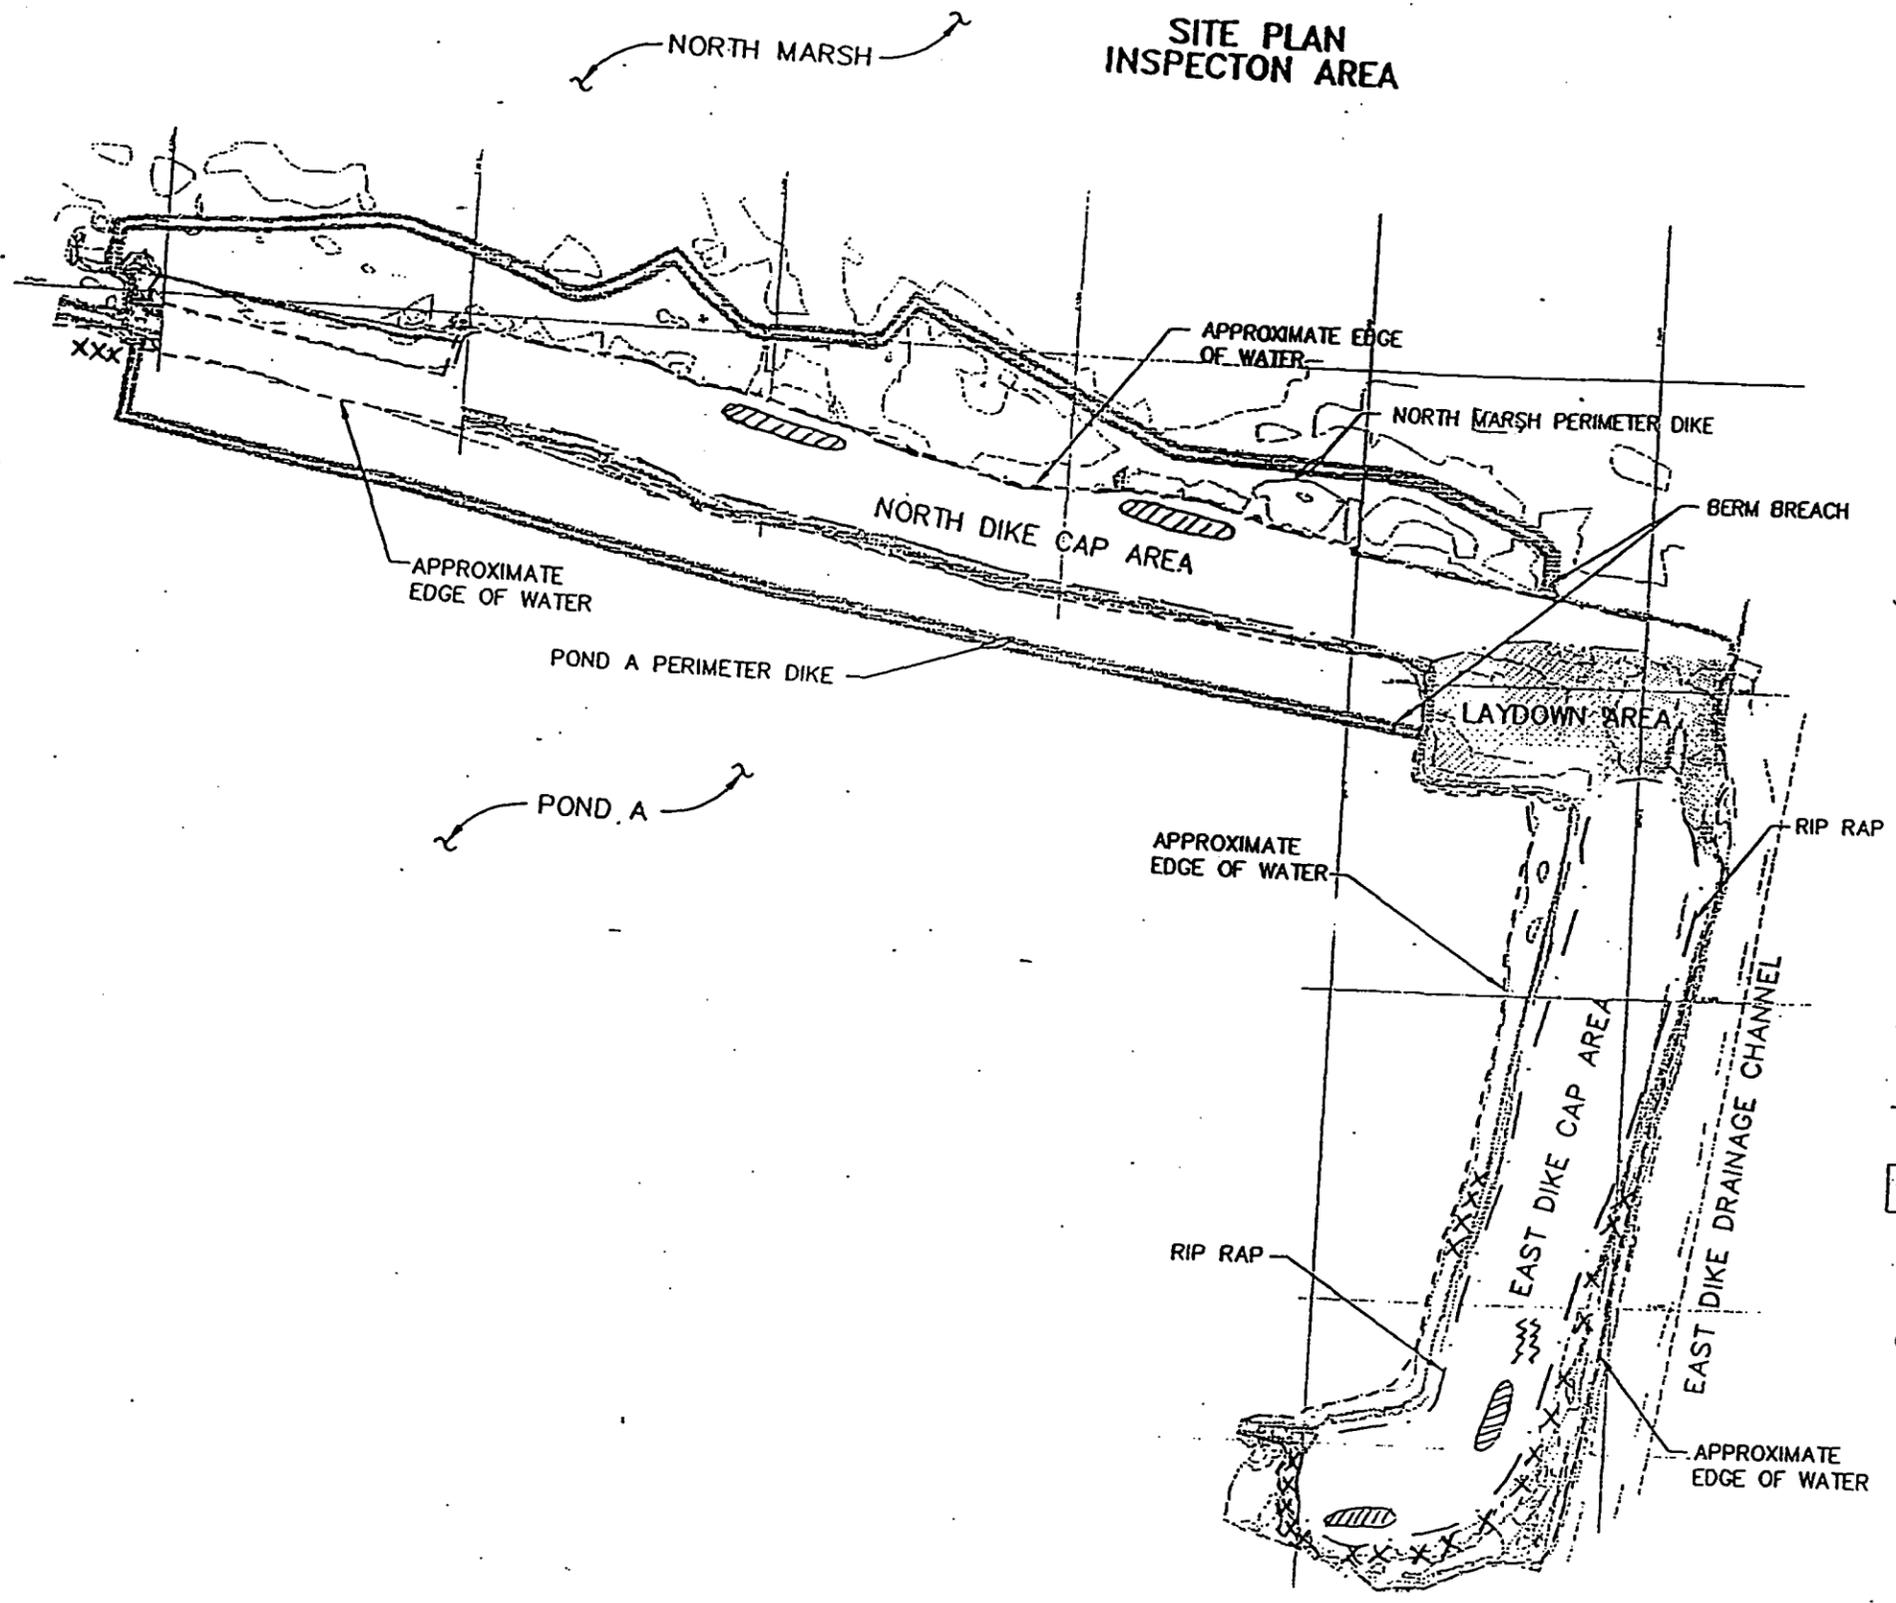
SITE MAP

The landfill caps were inspected for signs of erosion, exposure, differential settlement, and ponding. The condition of the surface vegetation and the gas vents were also noted. Areas of stressed vegetation are noted on the map in Appendix B. No grass needs to be re-seeded. Some woody plants are growing along the outer edge of both cap areas as illustrated on the map. These will be removed to prevent them from spreading onto the cap slopes and caps themselves. No erosion along the dike slopes and caps is evident. There are also some signs of minor soil desiccation on the East Dike Cap near the southern end (see map in Appendix B).

The fencing at the site was inspected and found to be in good condition. The gates and locks were also inspected and found to be in good condition, except that the chain and lock around the gate at the southwest side of the East Dike Cap are not wrapped around the gateposts. Entrance is possible through this gate. The site owner, Mr. Rodney Townsend, was advised of this condition and the need for correction. The signs located around the perimeter of the site are generally in good condition. One of the signs on the

- Some vegetation on caps was stressed due to the lack of rainfall. These areas should recover with rainfall. Therefore, no action is required;
- Minor soil desiccation was observed on East Dike Cap. This condition will recover with rainfall. No action is required;

- Woody plants were noted growing along the edges of both caps. These plants will be removed to prevent further propagation;
- The chain and lock on the southern gate of East Dike Cap are not installed properly. The lock will be replaced with one identical to the main gate and the chain will be secured around both gateposts to prevent entrance. A verbal request to Rodney Townsend was made at the time of the inspection to complete this task and a written request was made in September 2000; and
